Dam Safety Inspection Report

Name: **Shadow Lake**
State ID: **81.02** NID ID: **VT00070**
Hazard Class: **Significant**

Town: **Glover**
Watershed: **Barton River**
Stream: **Barton River-TR**

Inspection date: 06/28/2023 10:56

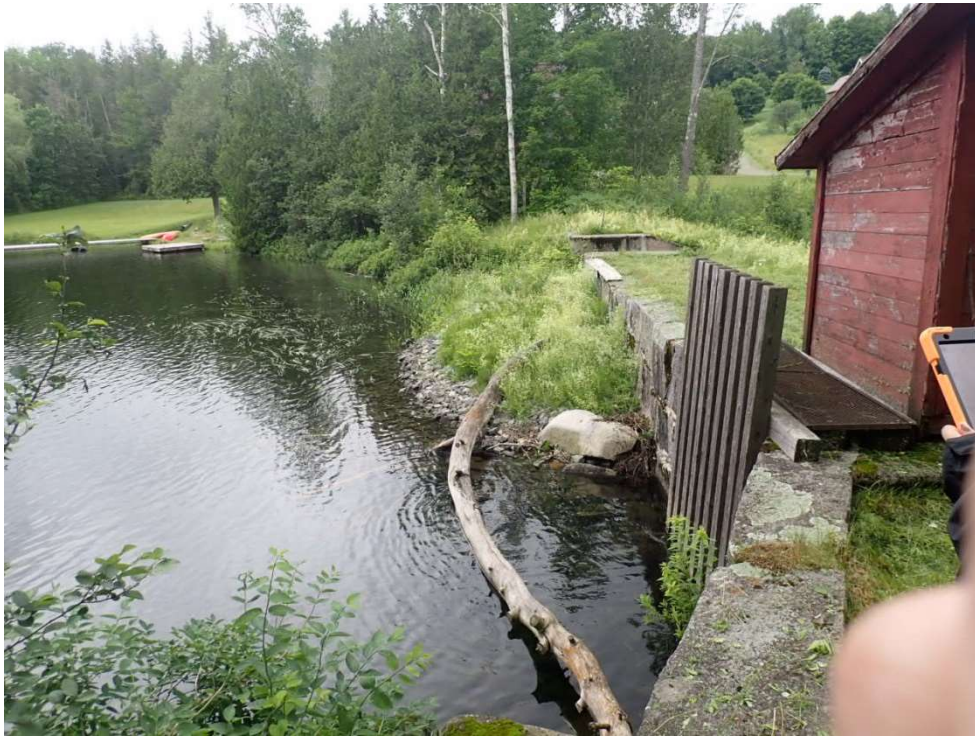
Crest images

Crest issues	Action
<p>Other vegetation Description: Tall grass Quantity: Dense Location: Left End</p>	<p><input type="checkbox"/> None <input type="checkbox"/> Monitor <input checked="" type="checkbox"/> Maintenance <input type="checkbox"/> Engineer</p>
<p>Additional comments: Vegetation to the left of the auxiliary spillway is too tall and needs to be cut.</p>	
<p>Sinkhole Description: Approximately 4 feet long, and max 3.5 feet deep Location: Crest, between gate house and auxiliary spillway</p>	<p><input type="checkbox"/> None <input checked="" type="checkbox"/> Monitor <input checked="" type="checkbox"/> Maintenance <input type="checkbox"/> Engineer</p>
<p>Additional comments: A sinkhole was observed in the dam crest during a rapid post flood inspection which took place on 7/18/2023. The rapid inspectors indicated that the sinkhole was located between the gate house and the auxiliary spillway and was approximately 4 feet long and a stick could be inserted 3.5 feet deep.</p> <p>Backfill with compacted granular fill and monitor the sinkhole area and areas upstream and downstream for signs of subsidence. If the sinkhole begins to redevelop or other adverse conditions are observed, contact the Dam Safety Program.</p>

Maintenance level recommendations	
<i>Crest</i>	<ul style="list-style-type: none"> • Cut tall vegetation on dam crest. • A sinkhole was observed in the dam crest during a rapid post flood inspection which took place on 7/18/2023. The inspectors indicated that the sinkhole was located between the gate house and the auxiliary spillway and was approximately 4 feet long and a stick could be inserted 3.5 feet deep. Backfill the sinkhole with compacted granular fill and monitor the sinkhole area and areas upstream and downstream for signs of subsidence. If the sinkhole begins to redevelop or other adverse conditions are observed, contact the Dam Safety Program.
<i>Downstream slope area</i>	<ul style="list-style-type: none"> • Cut tall vegetation on downstream slope. • Regularly monitor seepage, leakage, and/or wet areas for changes in flow, turbidity, or size.
<i>Spillways</i>	<ul style="list-style-type: none"> • Maintain the principal and/or auxiliary spillway free of debris to ensure free-flow conditions. • Cut vegetation in front of, around, and below auxiliary spillway. • Monitor the condition of the auxiliary spillway concrete, and perform minor surficial repairs as needed. • See additional comments under the principal spillway section regarding the principal spillway trash rack and knife gate. • See additional comments under the auxiliary spillway section about previously observed seepage.

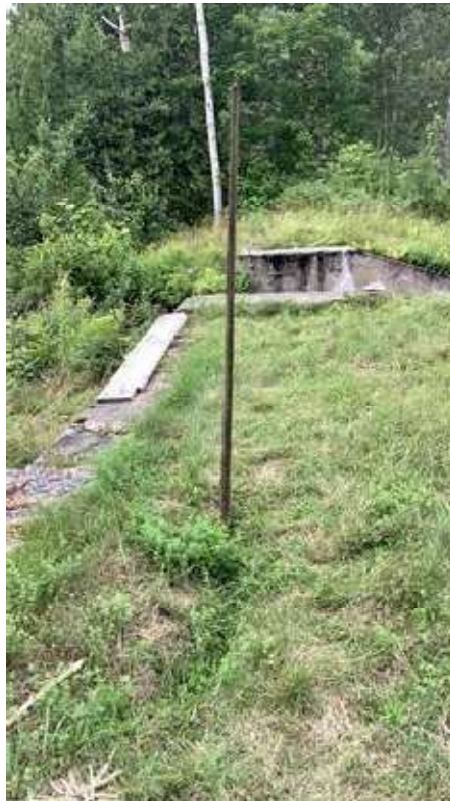
This photo was taken on 7/18/2023 as part of the rapid inspection program (sinkhole).

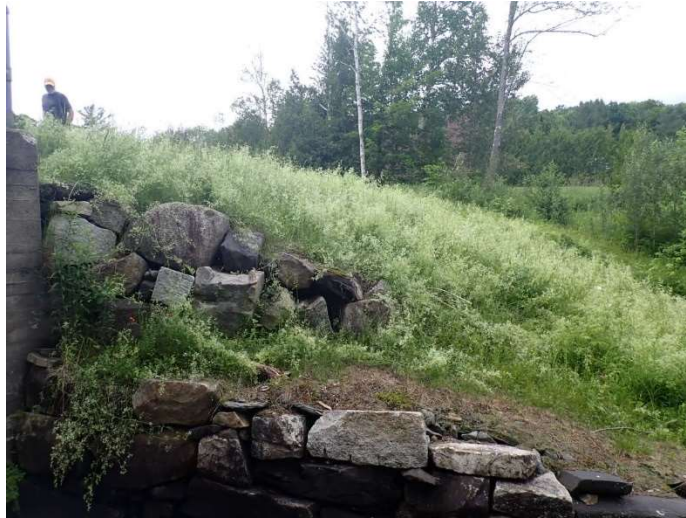
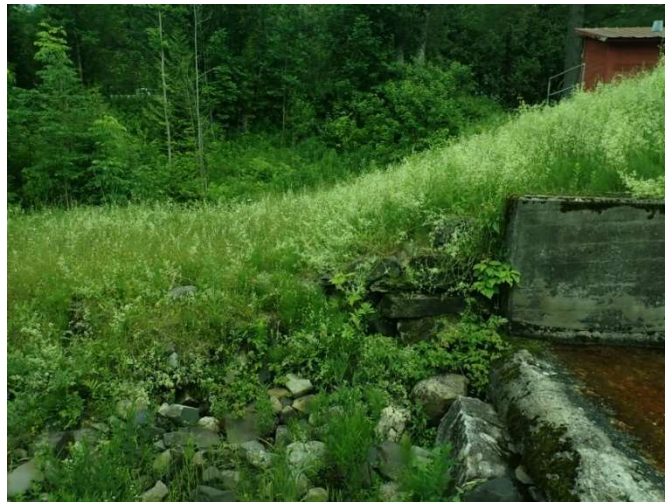
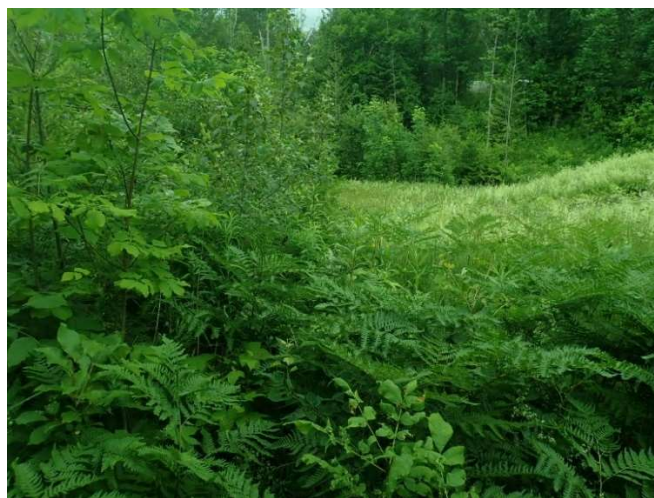
Downstream slope images

Downstream Slope
<p>General slope inclination: 3H:1V (slopes are within generally accepted stable inclinations). Downstream slope appears stable based on visual observation under current loading conditions.</p>
<p>Additional comments: none</p>

Downstream slope protections	Action
<p>Vegetation Condition:</p> <p> <input type="checkbox"/> Adequate <input type="checkbox"/> Bare <input checked="" type="checkbox"/> Too tall <input type="checkbox"/> Improper <input type="checkbox"/> Sparse <input type="checkbox"/> Too short </p> <p>Comments: Vegetation prevented a thorough inspection of the downstream slope. The previous 2017 periodic inspection observed seepage and iron staining near the right side (looking downstream) toe of the dam.</p>	<p> <input type="checkbox"/> None <input type="checkbox"/> Monitor <input checked="" type="checkbox"/> Maintenance <input type="checkbox"/> Engineer </p>

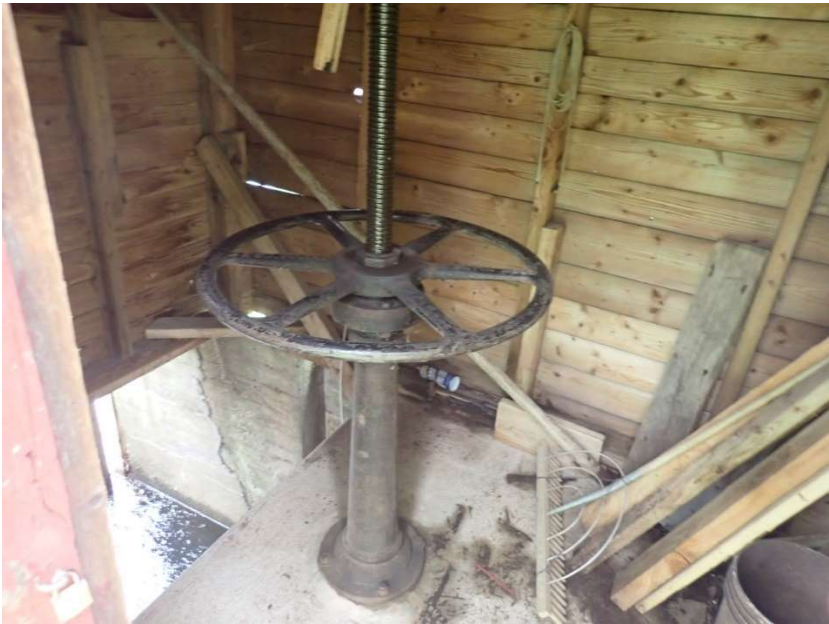
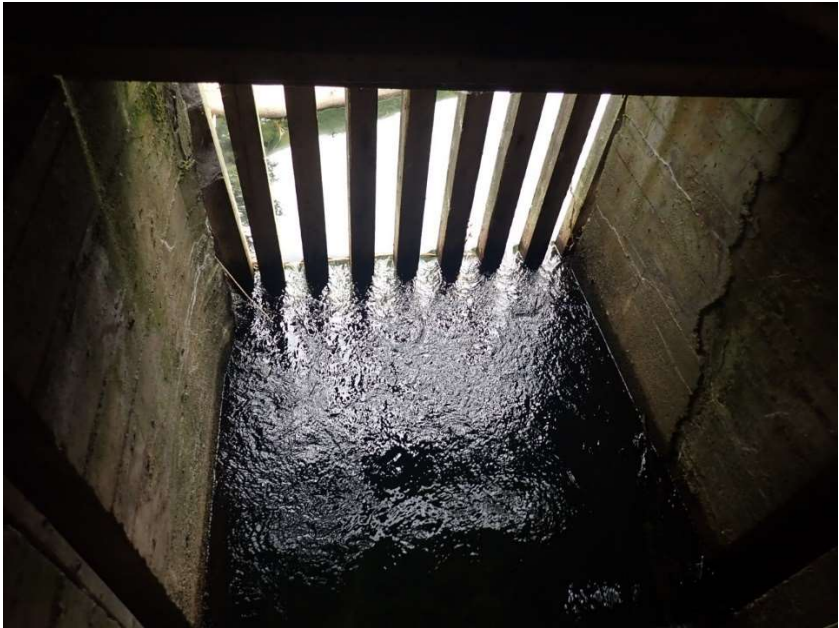
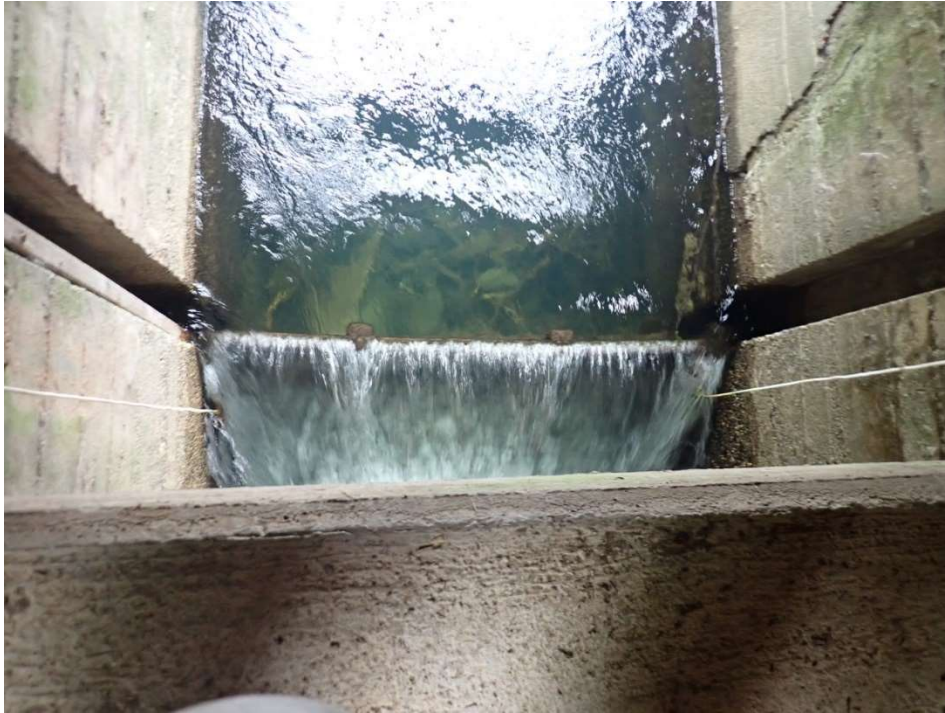
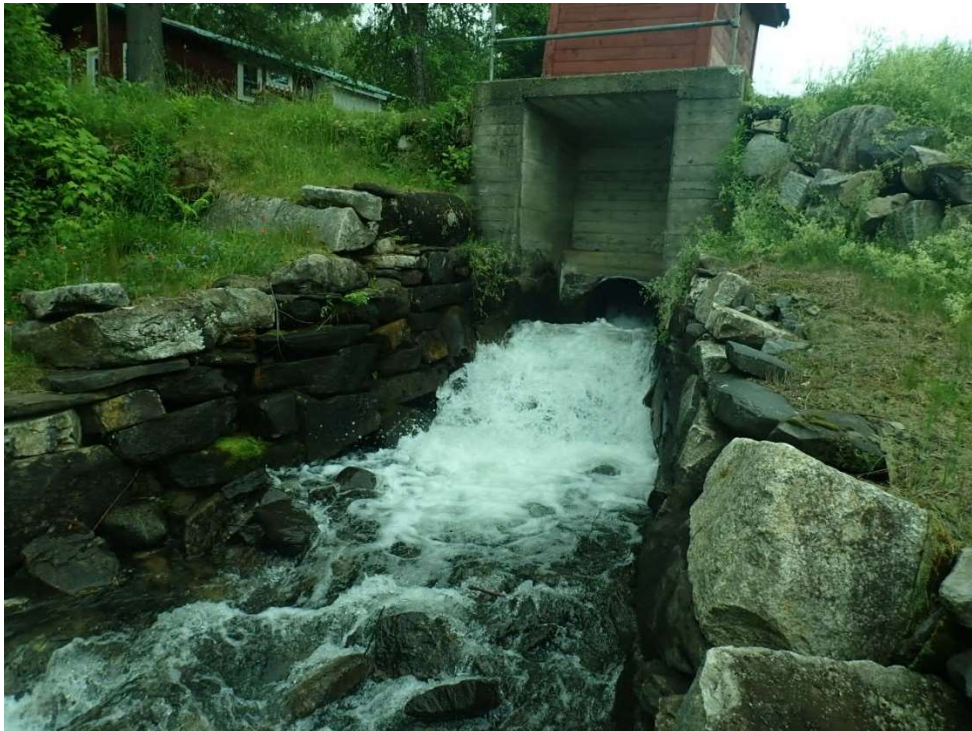
Principal spillway images

Additional comments: A timber trash rack sits in front of the principal spillway stop logs to prevent debris from clogging the spillway. The limited spacing in between the vertical bars results in head loss/flow restriction as indicated in the 2022 H&H study. While the purpose of the trash rack is to limit the potential for debris to get into and clog the spillway, it is recommended that the owner test an alternative debris rack configuration or remove some of the vertical bars to reduce the head loss. A dam order (permit) would not be required to perform this work.

The 2022 H&H study also notes that the slide gate partially blocks the outlet of the principal spillway gate house even with gate stem cranked fully open. This does not appear to influence normal flow conditions, but it may limit outflows under high flow events.

There is no standalone low-level-outlet, removal of the principal spillway stop logs would allow for a partial drawdown of the impoundment. The stop logs could not be thoroughly inspected. Observable portions appeared to be in fair condition.

Principal spillway issues	Action
<p>Trash rack Type: Timber Opening size: Too Small Condition:</p> <p> <input checked="" type="checkbox"/> Good <input type="checkbox"/> Collapsed <input type="checkbox"/> Missing sections <input type="checkbox"/> Broken bars <input type="checkbox"/> Rusted </p>	<p> <input type="checkbox"/> None <input type="checkbox"/> Monitor <input checked="" type="checkbox"/> Maintenance <input type="checkbox"/> Engineer </p>
<p>Slide Gate Type: Metal, Gate Stem, Handwheel Opening size: Too Small Condition:</p> <p> <input checked="" type="checkbox"/> Good <input type="checkbox"/> Leakage <input type="checkbox"/> Missing Sections <input type="checkbox"/> Broken <input type="checkbox"/> Rusted </p>	<p> <input type="checkbox"/> None <input type="checkbox"/> Monitor <input type="checkbox"/> Maintenance <input checked="" type="checkbox"/> Engineer </p>

It is the Departments understanding that the Owner periodically closes this gate to equalize water pressure on the stop logs for installation/removal/maintenance. Elimination of this gate is not recommended since it serves an important operation and maintenance function, but the Owner should investigate why the gate does not fully open, and whether maintenance level modifications can be made to fix this issue, or alternatively pursue replacement.

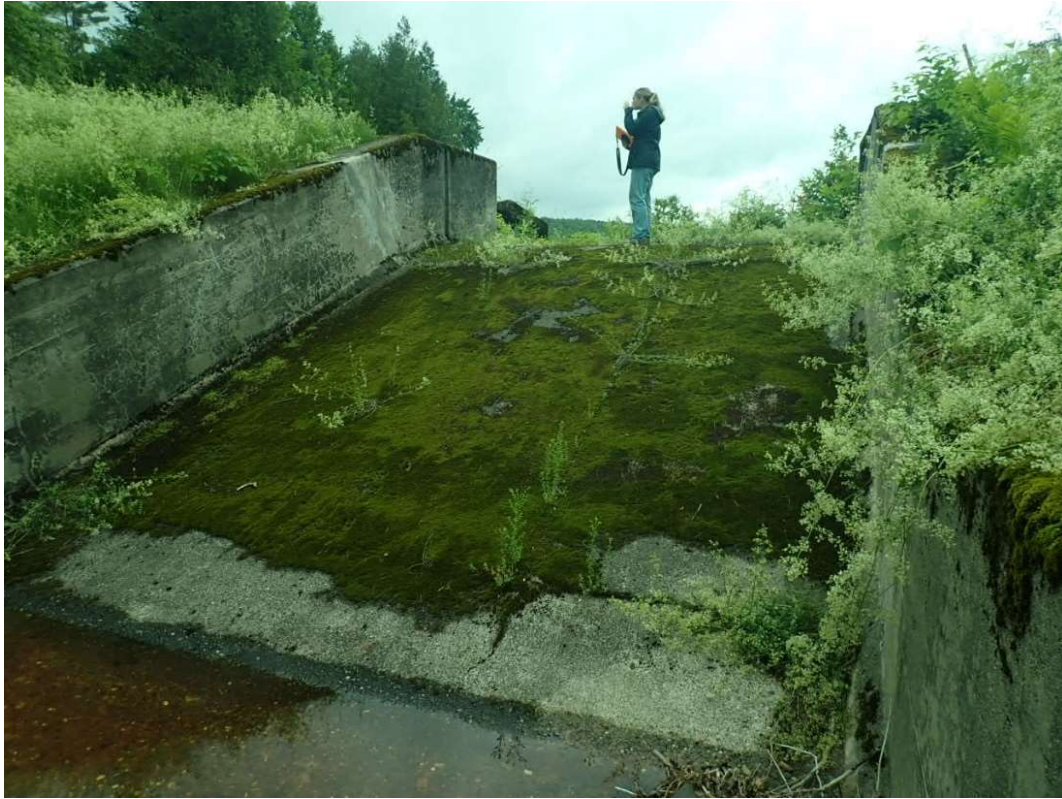
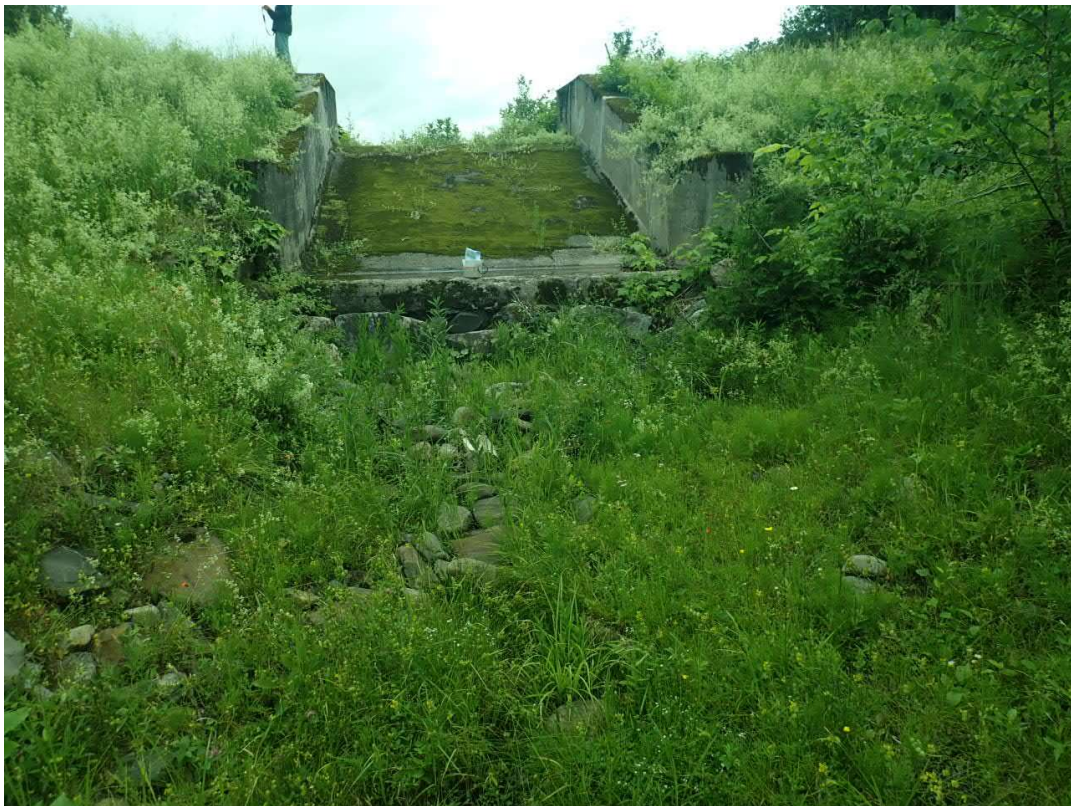
Auxiliary spillway images

Auxiliary Spillway	
Spillway type: Weir	Primary material: Concrete Weir: Broad-Crested
Spillway location: Left abutment	
Water level measured against principal auxiliary crest: Not measured	Erosion control structures: Riprap
Spillway components:	
<input type="checkbox"/> Anti-vortex plate	<input type="checkbox"/> Filter Diaphragm <input checked="" type="checkbox"/> Training Walls
<input type="checkbox"/> Flashboard	<input type="checkbox"/> Trashrack <input type="checkbox"/> Other:
<p>Additional comments: On April 28, 2023, approximately 20 gallons per minute of seepage was previously observed near the left (looking downstream) bottom corner of the auxiliary spillway. At the time of this inspection the pool elevation was measured to be 3-inches below the dam’s auxiliary spillway crest (approximately 16 inches above normal pool).</p> <p>At the time of this June 28, 2023 inspection above-mentioned seepage was not observed. The water level at the time of this inspection was observed approximately 2-inches above normal pool. Some water was pooled below the base of the auxiliary spillway. It had recently rained, and it was unclear if this water was from seepage or not. The pooled water did not appear to be actively flowing.</p> <p>While the seepage path potentially could have self-healed, it should be noted that the pool elevation during the April 28, 2023 site visit was approximately 14 inches higher than during this June 28, 2023 inspection.</p> <p>It is recommended that the owner continue to periodically monitor this area for seepage paying special attention to elevated pool conditions and keeping an eye out for any changing conditions. Cutting the tall vegetation will make it easier to monitor for seepage.</p>

Auxiliary spillway issues	Action
<p>Other Description: Vegetation growth, too tall Location: in front of, below, and beside</p>	<input type="checkbox"/> None <input type="checkbox"/> Monitor <input checked="" type="checkbox"/> Maintenance <input type="checkbox"/> Engineer
<p>Undermining/Seepage Description: Over the years the channel below the auxiliary spillway has experienced erosion from turbulent flow. The end of the spillway slab has been partially undermined. Voids range from 6 to 18 inches deep. Large stones have been placed along the base of the spillway to help reduce the potential for further erosion to occur, however this is not an engineered design, and it is unclear if this measure will perform satisfactory under the inflow design flood loading condition. This is the same location where seepage unearths the spillway slab has been historically observed.</p> <p>Location: End of spillway, below slab</p>	<input type="checkbox"/> None <input checked="" type="checkbox"/> Monitor <input type="checkbox"/> Maintenance <input checked="" type="checkbox"/> Engineer

Auxiliary spillway issues	Action
<p>Concrete deterioration Description: There are visible signs of wear and deterioration along the entirety of the auxiliary spillway. The concrete has been patched/repared in some places along the training walls. Concrete is in fair condition for its age.</p>	<p> <input type="checkbox"/> None <input checked="" type="checkbox"/> Monitor <input type="checkbox"/> Maintenance <input type="checkbox"/> Engineer </p>

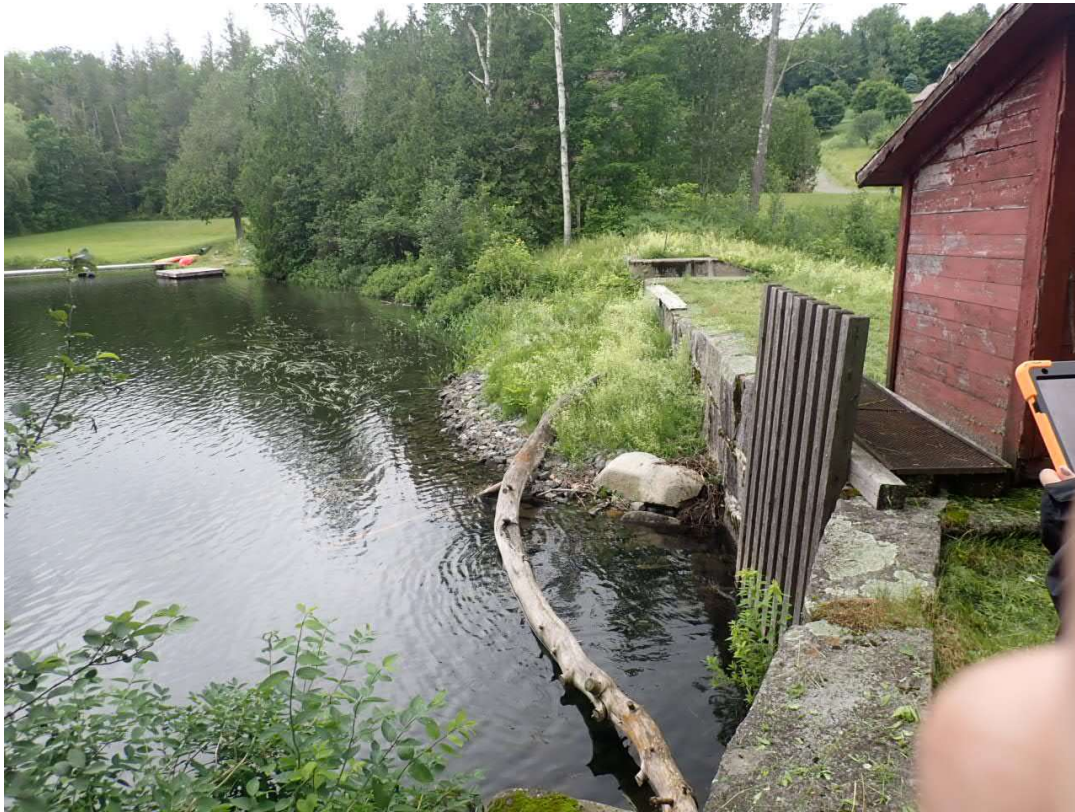
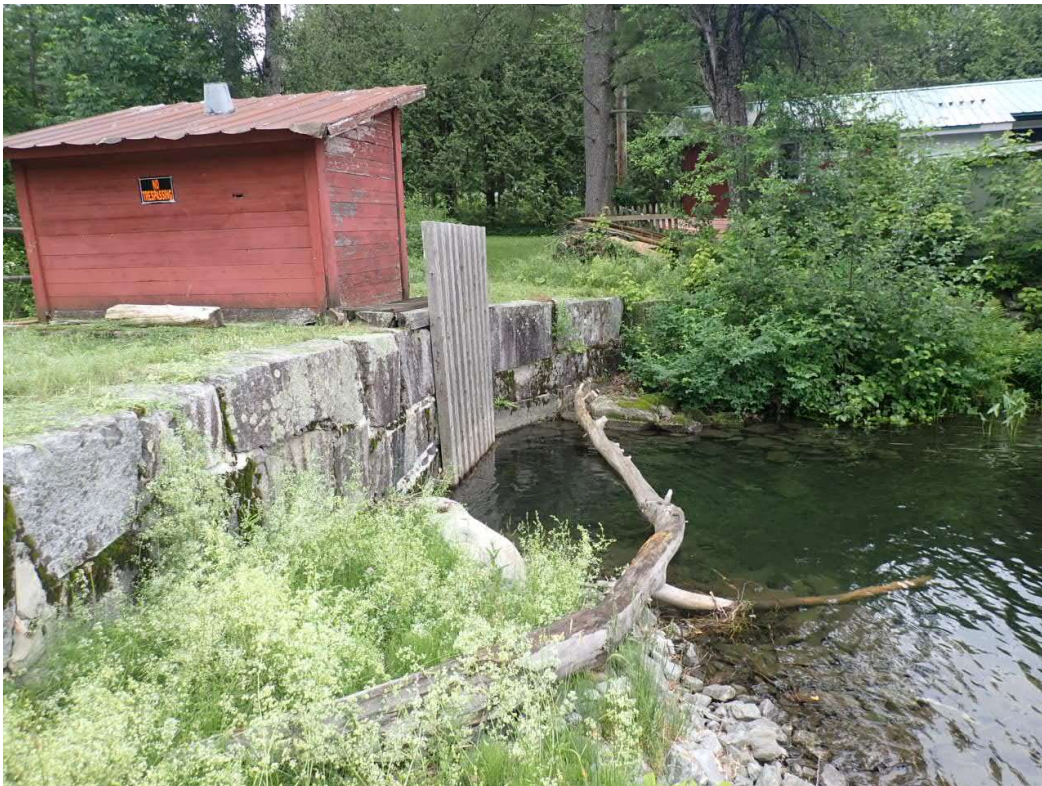
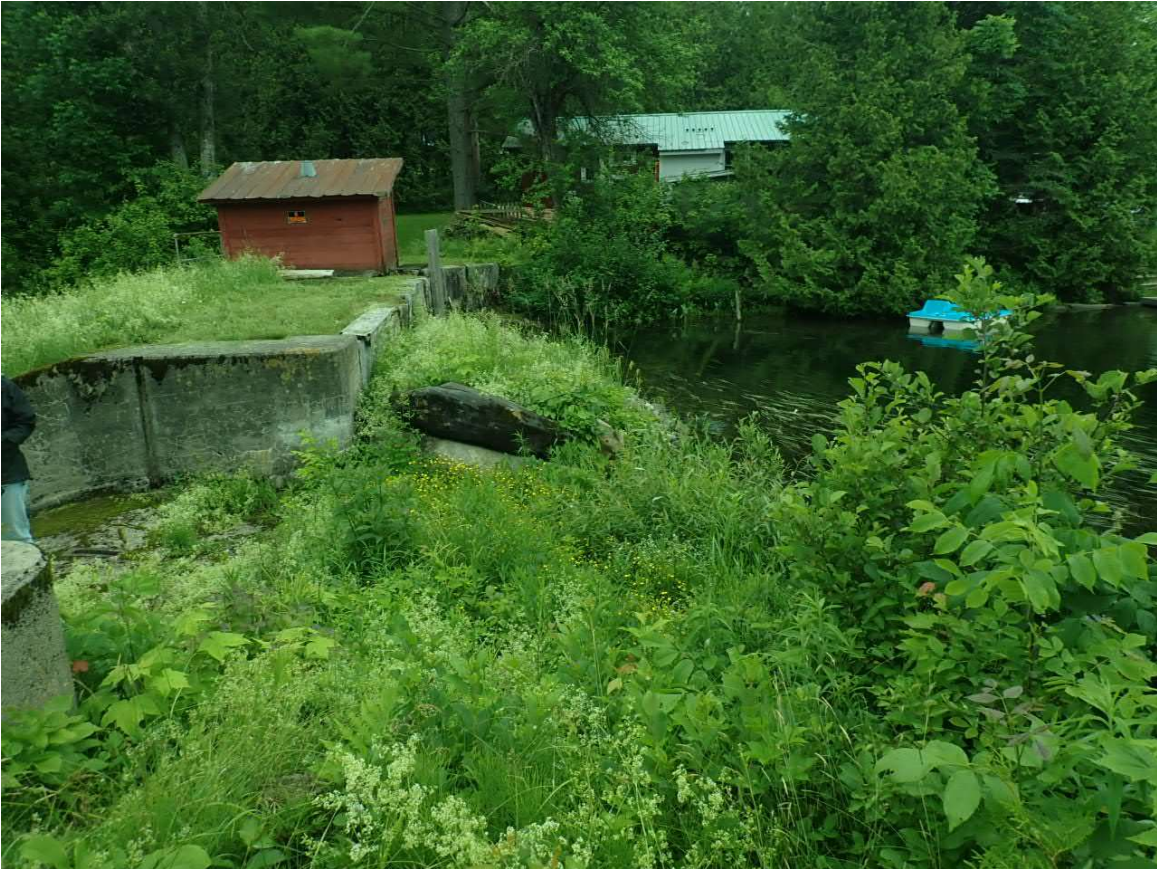
Upstream wall images

Upstream Wall		
Wall type: Stone Masonry Length: 130 ft		
Wall height (exposed): 5.2 ft above normal pool	Horizontal wall alignment: Good	Vertical wall alignment: Good
Unusual wall movement: <input type="checkbox"/> Yes <input checked="" type="checkbox"/> No		
Additional comments: Stone/riprap has been placed in front of the wall; tall vegetation is growing on the stone/riprap which prevented thorough inspection.		Surface condition: Fair to Good
Joint condition: Good		Abutment contact condition: Good

Upstream wall issues	Action
Vegetation Condition: <input type="checkbox"/> Adequate <input type="checkbox"/> Bare <input type="checkbox"/> Improper <input type="checkbox"/> Sparse	<input type="checkbox"/> None <input type="checkbox"/> Monitor <input checked="" type="checkbox"/> Too tall <input checked="" type="checkbox"/> Maintenance <input type="checkbox"/> Too short <input type="checkbox"/> Engineer
Comments: none

<i>Low-level outlets</i>	<ul style="list-style-type: none"> • Periodically monitor and inspect the condition of the stoplogs and take measures to reduce leakage as necessary.
<i>Embankment walls</i>	<ul style="list-style-type: none"> • Cut vegetation in front of the masonry wall.
