MEMORANDUM

DATE: July 26, 2024

SUBJECT: July 2024 Flood Inspection and Recommendations
Shadow Lake Dam (State ID No. 81.02), Glover, Vermont
SIGNIFICANT Hazard Potential

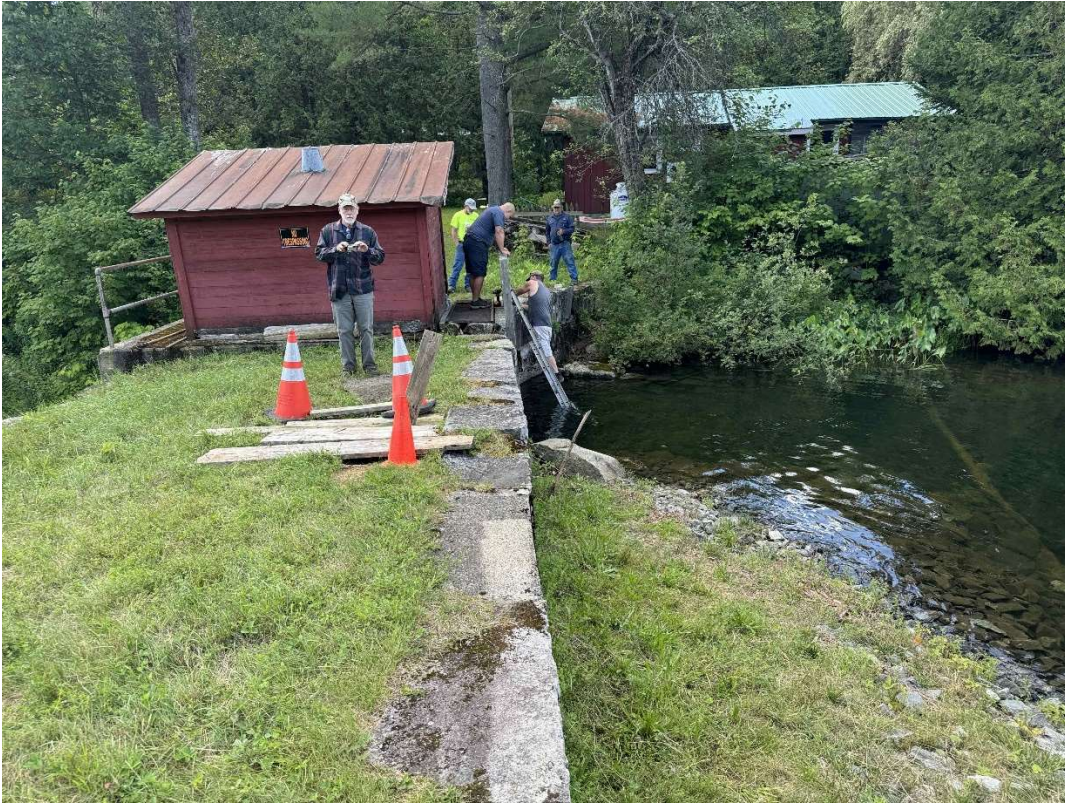
2. At the time of the inspection the owner was in the process of removing two timbers from the principal spillway debris rack to allow for increased discharge. This work was completed by the end of the inspection.

Photo 1: Dam crest, sinkhole, principal spillway derbis rack timber removal (looking towards right abutment).

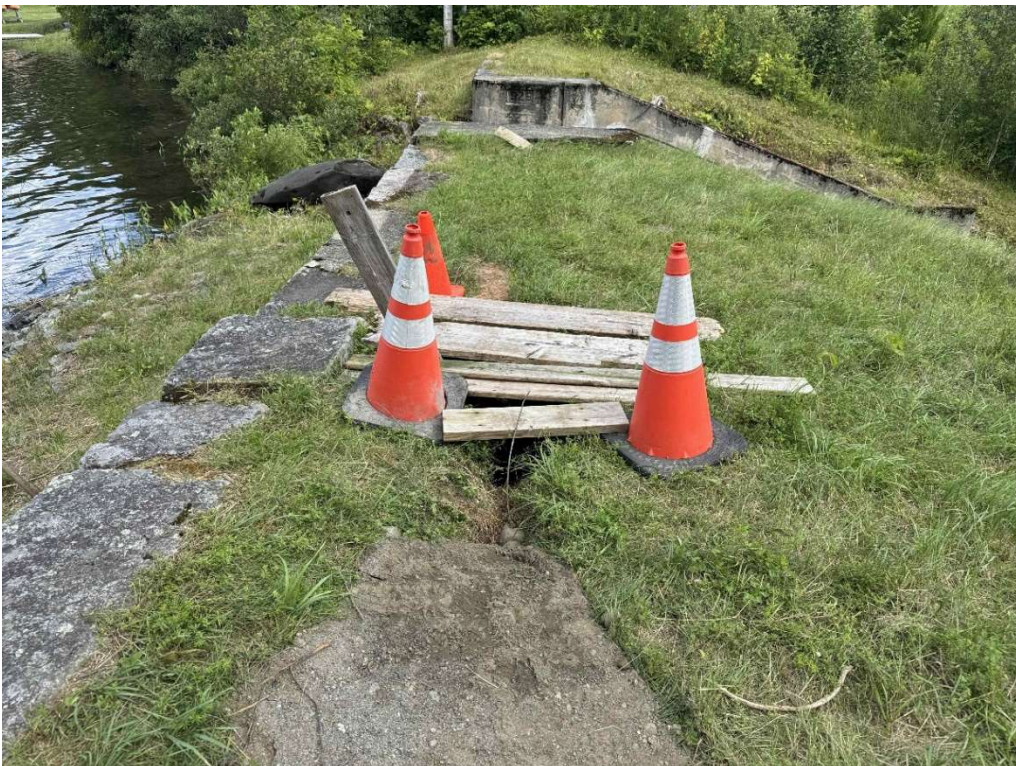
1. The sinkhole along the dam crest identified in the July 18, 2023 Rapid Inspection has increased considerably in size and depth. The sinkhole was measured to be approximately 5 feet in diameter and 5 feet deep. The owner was present during the inspection and noted that they were able to see active flow within the sinkhole during a previous site visit. It is therefore likely that the sinkhole extends into the dam embankment beyond what is visible. In addition to the sinkhole located on the dam crest, the owner showed the DSP a depression along the upstream face of the masonry block wall in close vicinity to the dam crest sinkhole. The owner indicated that the depression may be a location where water was seepage past the upstream masonry wall. It was noted that the masonry block wall has numerous additional un-mortared joints/gaps for water to seep through. The owner also pointed out that the sinkhole appeared to be expanding towards the direction of the bottom of the concrete auxiliary spillway. Historically, seepage flows have been observed at the base of this spillway. While it could not be confirmed that these two locations are directly connected, seepage flow was again observed below the base of the auxiliary spillway at the time of the inspection. The observed seepage was warm to the touch indicating it was likely near surface water from the lake and was flowing through the dam with a short travel time. The seepage did not appear cloudy or to be transporting embankment materials. Due to the location of the seepage, it was not possible to measure the flow rate but it was visually estimated to be 10 to 20 gallons per minute.

Photo 2: Dam crest, sink hole (looking towards left abutment).

1. Continue to regularly monitor the dam and report any unusual/unsafe conditions to the DSP.
2. Without delay, temporarily lower the water level until the sinkhole and other seepage pathways have been thoroughly investigated and repaired in accordance with an engineered and approved solution.

- Systematically remove stoplogs to provide a minimum of 2 feet of drawdown in the lake to reduce loading on the dam and reduce seepage pressures in the embankment. This can likely be achieved by removing one stoplog from the principal spillway structure and once the water level has stabilized, additional stoplogs as needed.

4. Retain an Engineer experienced in the evaluation and design of dams to evaluate the sinkhole, seepage, and stability of the dam. This work should include field investigations to determine the source and severity of seepage, explore the type and consistency of the embankment and foundation soils and rock, and evaluate the seepage and structural stability of the dam. The work should also identify potential repair alternatives for review.

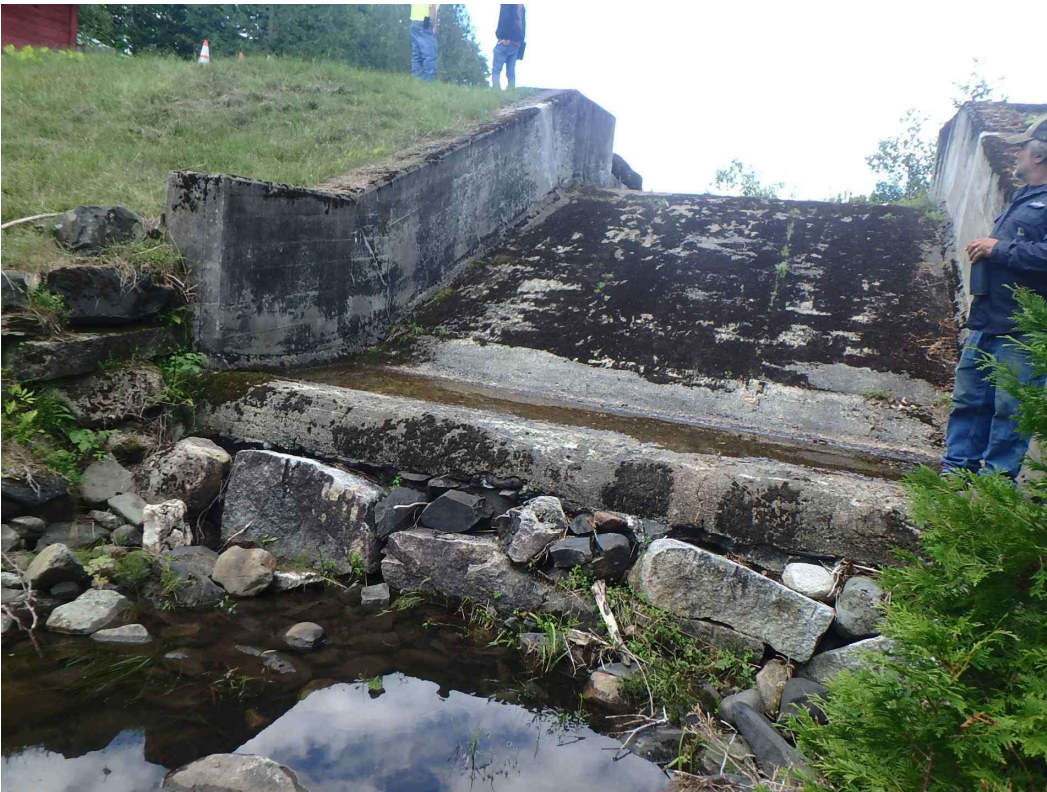
Photo 6: Water pooled below base of auxiliary spillway.
