SHADOW LAKE WATERSHED ACTION PLAN REPORT

PHASE 2 - STREAMS

DECEMBER 2025

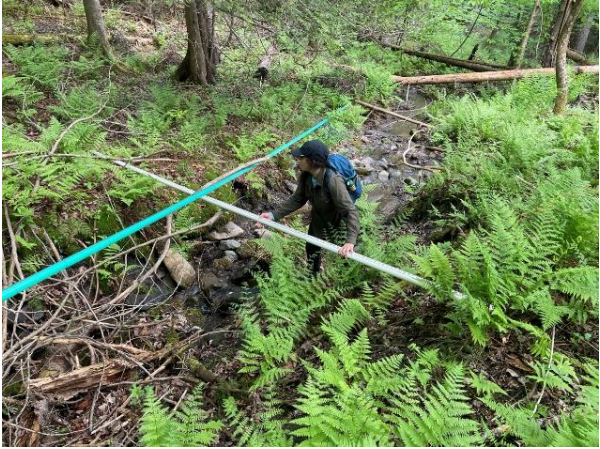
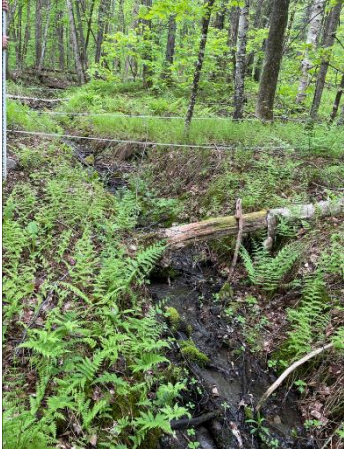
Potential Project Name: Ditch stabilization along an unnamed Shadow Lake Brook off Clark Rd in Glover					
Project Type:	Forestry - Design				
Lat/Long	44.676033, -72.231065				
Land Ownership:	Private				
Description: Ditched channel within sugarbush is gullying. Ditch is 11ft wide x 5.5ft deep in most erosive section.					
<div style="display: flex; justify-content: space-around;">

</div> <p style="text-align: center;">Unraveling ditch among saplines within sugarbush.</p>					
BMP Description: Consider stabilizing ditched channel with woody check dams to reduce water velocities, erosion, and sediment loading.					
WQ Benefits	Landowner Interest	Cost / Feasibility	O&M / Longevity	Co-Benefits	Total Score
10	0	5	2	2	19
Phosphorus Reduction: 0.93 kg/P/yr					
Landowner Interest: No contact made.					
Cost / O&M: \$10,000 - \$15,000. Low cost and maintenance.					
Notes/Comments: Phosphorus reduction calculations were conservative given the average dimensions of the gully were on the small end. Co-benefits include improving flood resilience and sustainable timber harvest land use compatibility. Potential permits include a Stream Alteration permit, Army Corps General permit, and wetlands general permit.

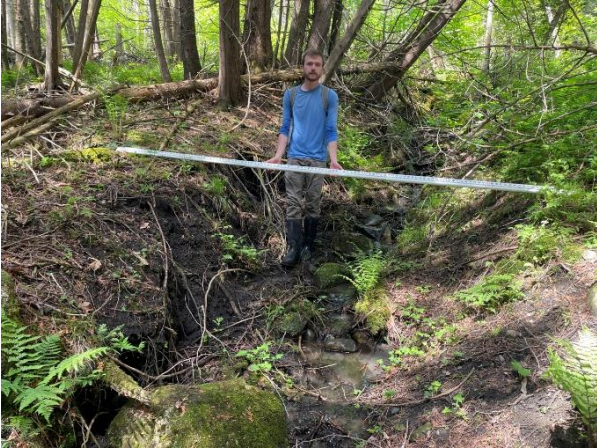
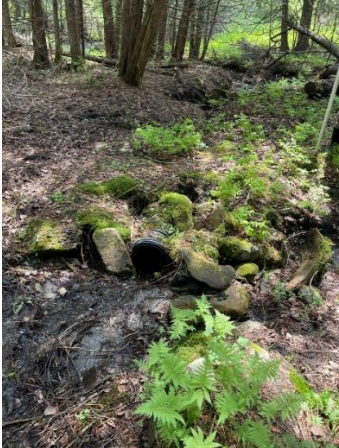
Potential Project Name: Forest road stabilization along an unnamed Shadow Lake brook off Danforth Rd in Glover					
Project Type:	Forestry - Design				
Lat/Long	44.675424, -72.230621				
Land Ownership:	Private				
<p>Description: Gullying forest road and ditch that is eroding and concentrating flows to the stream. Gully originates above springs alongside road and continues down the road surface and into the ditch. Undersized forest road crossing upstream of the outlet to the brook with evidence of overtopping.</p>					
<div style="display: flex; justify-content: space-around;">

</div> <p style="text-align: center;">Forest road ditch gullying (left) and undersized cross culvert (right).</p>					
<p>BMP Description: Stabilize forest road and apply disconnection practices such as waterbars, swales, and turnouts. Upsize crossing structure to allow passage of high flows. Consider closing out road sections that are no longer in use. Opportunity for road decommission or road obliteration methods to restore hillslope hydrology and reduce sediment loading.</p>

WQ Benefits	Landowner Interest	Cost / Feasibility	O&M / Longevity	Co-Benefits	Total Score
12	2	5	2	2	23
<p>Phosphorus Reduction: 6.21 kg/P/yr</p>					
<p>Landowner Interest: Landowner is interested.</p>					
<p>Cost / O&M: \$10,000 – \$15,000, Low cost and maintenance</p>					
<p>Notes/Comments: Phosphorus reduction value includes 5.32 kg/P/yr (forest rd) + 0.89 kg/P/yr (culvert upgrade), note that forest road phosphorus calculations are expected to be reduced following the reworking of the forest road interim P calculator. Co-benefits include improving existing BMPs and sustainable timber harvest land use compatibility. Potential permits include Stream Alteration permit, Army Corps General permit, and wetlands registration. Cutting of trees greater than 3” diameter may impact potential bat roosting habitat.</p>

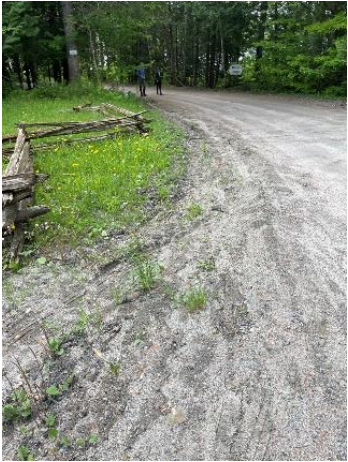
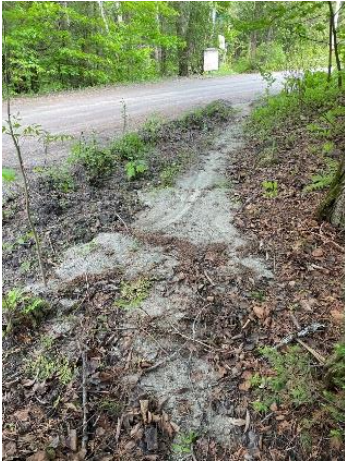
Potential Project Name: Road Erosion BMPs along Maynard Dr in Glover					
Project Type:	Road Project - Implementation				
Lat/Long	44.674911, -72.229131				
Land Ownership:	Private				
<p>Description: Road runoff from Clark Rd connects flows to unnamed tributary. Approximately 80ft of Maynard Drive flows to the stream crossing.</p>					
<div style="display: flex; justify-content: space-around;">

</div> <p>Road runoff flowing from Clark Rd to Maynard Dr crossing.</p>					
<p>BMP Description: Regrade road surface to improve sheet flow to adjacent wooded areas, consider installing a waterbar and or turnout to disconnect concentrated flows.</p>					
WQ Benefits	Landowner Interest	Cost / Feasibility	O&M / Longevity	Co-Benefits	Total Score
9	0	6	2	2	19
<p>Phosphorus Reduction: 0.036 kg/P/yr</p>					
<p>Landowner Interest: No contact made</p>					
<p>Cost / O&M: \$5,000, Low expense & labor requirements</p>

<p>Notes/Comments: Co-benefits include improving existing BMPs and enhancing lakeshore natural communities. No permits are required if work is limited to the existing road ROW.</p>

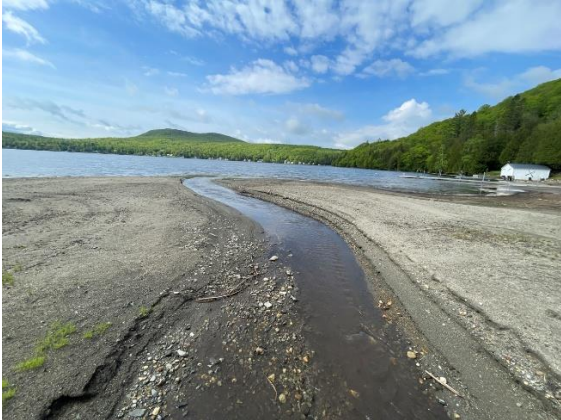
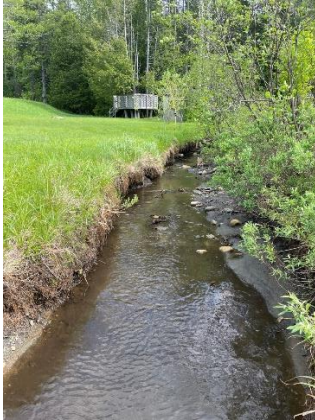
Potential Project Name: Buffer planting along unnamed brook and Shadow Lake confluence off Danforth Rd in Glover					
Project Type:	River - Planting				
Lat/Long	44.674398, -72.229037				
Land Ownership:	Private				
Description: Lakeshore and stream have inadequate woody buffer. Stream outlet with large delta of sediment.					
<div style="display: flex; justify-content: space-around;">

</div> <p style="text-align: center;">Shadow lake shoreline and stream outlet without a woody buffer.</p>					
BMP Description: Widen no mow zone and plant a woody buffer to improve filtration of nutrients, wildlife habitat, and shoreline & streambank stability. Consider planting low-growing woody species to maintain viewshed. Consider planting native wetland species throughout exposed delta sediments.					
WQ Benefits	Landowner Interest	Cost / Feasibility	O&M / Longevity	Co-Benefits	Total Score
5	2	6	2	2	17

Phosphorus Reduction: 0.16 kg/P/yr					
Landowner Interest: Landowner is interested.					
Cost / O&M: Less than \$5,000. Low expense & labor requirements					
Notes/Comments: Assumed a 35ft buffer width along the lakeshore and brook. Co-benefits include improving fish habitat and enhancing lakeshore natural communities. No permits required as buffer plantings are exempt practices.
