Dam Safety Inspection Report

Name: **Shadow Lake**
State ID: **81.02** NID ID: **VT00070**
Hazard Class: **Significant**

Town: **Glover**
Watershed: **Barton River**
Stream: **Barton River-TR**

Inspection date: 06/28/2023 10:56

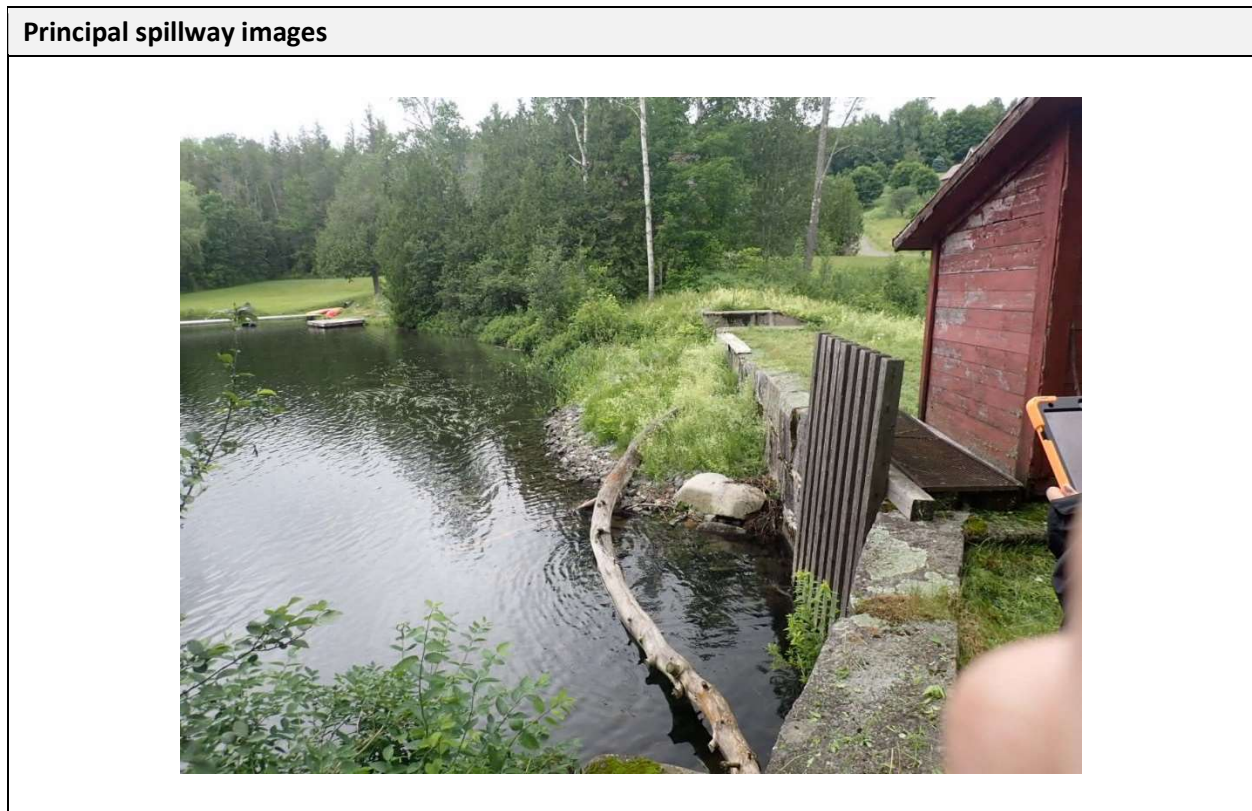
Principal spillway images

Additional comments: A timber trash rack sits in front of the principal spillway stop logs to prevent debris from clogging the spillway. The limited spacing in between the vertical bars results in head loss/flow restriction as indicated in the 2022 H&H study. While the purpose of the trash rack is to limit the potential for debris to get into and clog the spillway, it is recommended that the owner test an alternative debris rack configuration or remove some of the vertical bars to reduce the head loss. A dam order (permit) would not be required to perform this work.

The 2022 H&H study also notes that the slide gate partially blocks the outlet of the principal spillway gate house even with gate stem cranked fully open. This does not appear to influence normal flow conditions, but it may limit outflows under high flow events.

There is no standalone low-level-outlet, removal of the principal spillway stop logs would allow for a partial drawdown of the impoundment. The stop logs could not be thoroughly inspected. Observable portions appeared to be in fair condition.

Principal spillway issues	Action
<p>Trash rack Type: Timber Opening size: Too Small Condition:</p> <p> <input checked="" type="checkbox"/> Good <input type="checkbox"/> Collapsed <input type="checkbox"/> Missing sections <input type="checkbox"/> Broken bars <input type="checkbox"/> Rusted </p>	<p> <input type="checkbox"/> None <input type="checkbox"/> Monitor <input checked="" type="checkbox"/> Maintenance <input type="checkbox"/> Engineer </p>
<p>Slide Gate Type: Metal, Gate Stem, Handwheel Opening size: Too Small Condition:</p> <p> <input checked="" type="checkbox"/> Good <input type="checkbox"/> Leakage <input type="checkbox"/> Missing Sections <input type="checkbox"/> Broken <input type="checkbox"/> Rusted </p>	<p> <input type="checkbox"/> None <input type="checkbox"/> Monitor <input type="checkbox"/> Maintenance <input checked="" type="checkbox"/> Engineer </p>

It is the Departments understanding that the Owner periodically closes this gate to equalize water pressure on the stop logs for installation/removal/maintenance. Elimination of this gate is not recommended since it serves an important operation and maintenance function, but the Owner should investigate why the gate does not fully open, and whether maintenance level modifications can be made to fix this issue, or alternatively pursue replacement.

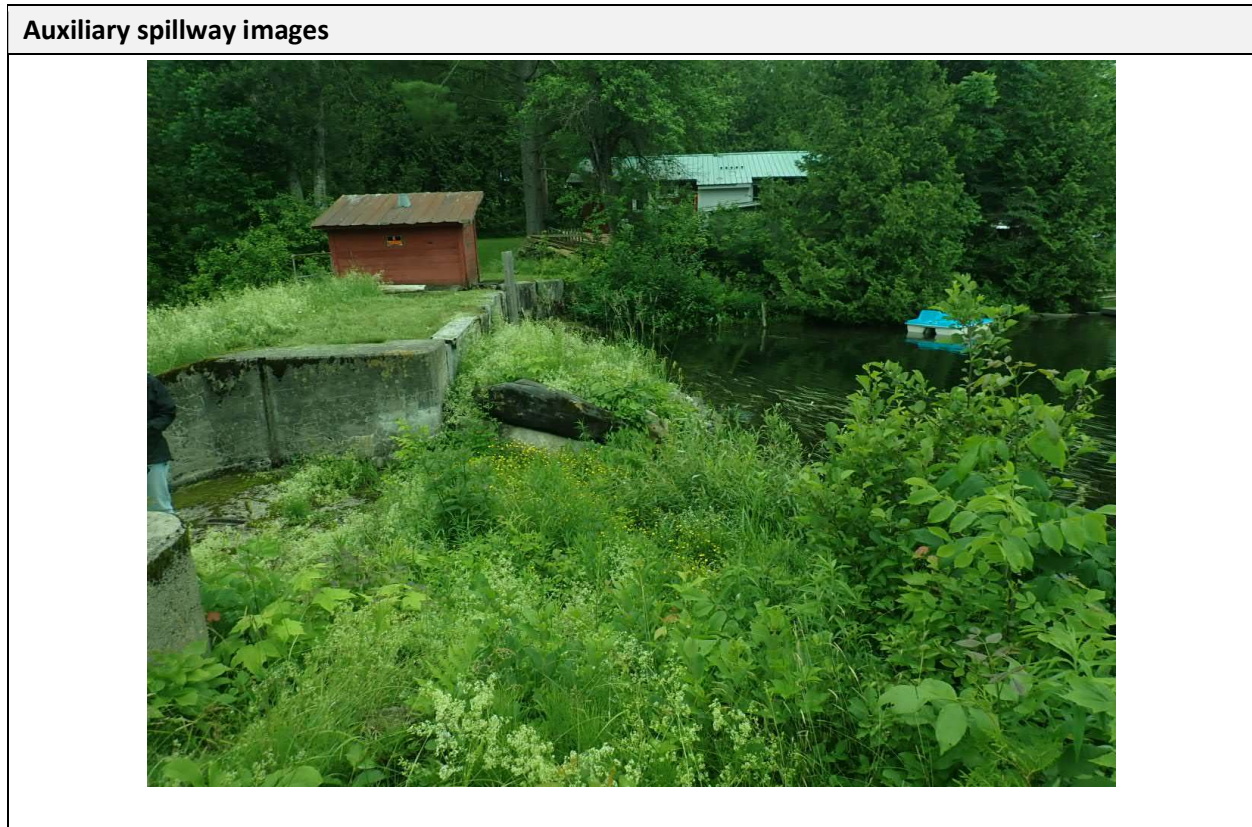
Auxiliary spillway images

Auxiliary spillway issues	Action
<p>Concrete deterioration Description: There are visible signs of wear and deterioration along the entirety of the auxiliary spillway. The concrete has been patched/repared in some places along the training walls. Concrete is in fair condition for its age.</p>	<p> <input type="checkbox"/> None <input checked="" type="checkbox"/> Monitor <input type="checkbox"/> Maintenance <input type="checkbox"/> Engineer </p>
